Early sudden distal conductor fracture of a stylet-driven lead implanted for left bundle branch area pacing

Raffael Thaler, MD,^{*} Moritz F. Sinner, MD, MPH,^{*†} Nader Joghetaei, MD,[‡] Stephanie Fichtner, MD^{*}

From the ^{*}Department of Cardiology, University Hospital, LMU Munich, Munich, Germany, [†]German Centre for Cardiovascular Research (DZHK), partner site: Munich Heart Alliance, Munich, Germany, and [‡]Ambulatory Care Office, Dr Joghetaei, Munich, Germany.

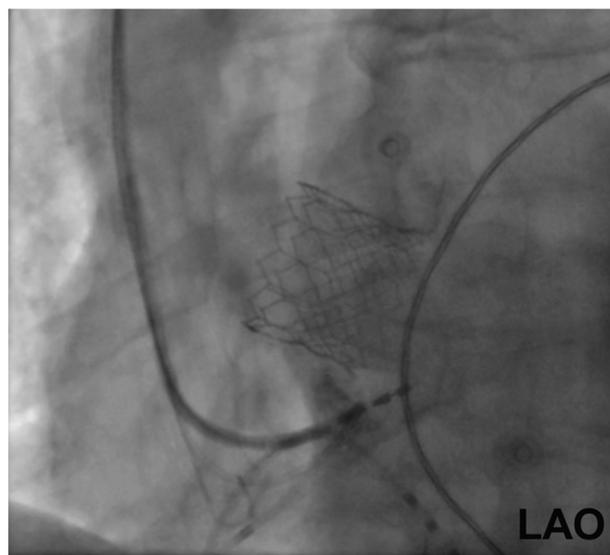
Figure 1 Left anterior oblique (LAO) projection demonstrating implantation depth during contrast dye injection at primary implantation.

Implantation was performed as previously described by Huang and colleagues,^{2,6} resulting in stable and good pacing thresholds, pacing impedance, and sensing amplitudes (0.5 V @ 0.4 ms; 351 Ω unipolar, 526 Ω bipolar, 13.5 mV; **Figure 1A**) after a third positioning attempt. The sheath was carefully peeled after retraction of the stylet, and pacing values remained stable. No special occurrences were noted. The procedure duration was 125 minutes (fluoroscopy time 15.3 minutes, 10 mL contrast dye). Pacemaker interrogation 3 months after implantation revealed constant lead parameters (0.6 V @ 0.4 ms; 351 Ω unipolar, 565 Ω bipolar, 12.8 mV).

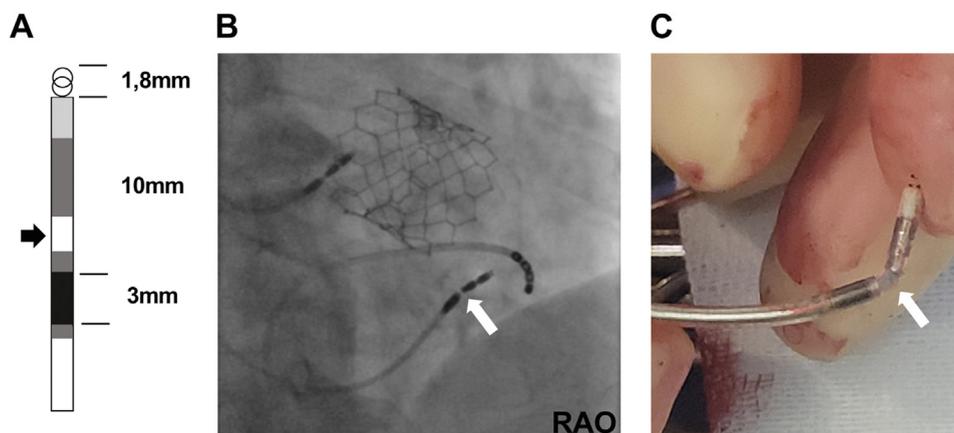
By fluoroscopy, the lead was in place in the ventricular septum, but a possible conductor fracture was visualized by a suggestive lead movement just before the ring electrode at the entry point into the septum (**Figure 2A–2C** and Supplemental Video). RV capture could be restored by reinserting a stylet in the pacing lead. The lead was subsequently extracted

Figure 2 **A:** Schematic structure of the Solia S lead (Biotronik) highlighting the conductor breaking point (black arrow). **B:** Right anterior oblique (RAO) projection demonstrating lead fracture distal to ring electrode (white arrow). **C:** Image of the explanted lead breaking point marked with white arrow.

Implantation of a stylet-driven lead via curved delivery sheaths for LBBAP is an attractive alternative to the wider spread use of lumenless leads. Owing to the additional stylet support, high implant success rates have been reported for LBBAP and HBP.^{4,5} Yet, the Solia S60 lead as used in the presented case comes with a more complex design and has a larger diameter of 5.9F, compared to 4.1F in lumenless leads. To date, only limited experience is available informing the performance of the Solia stylet system for LBBAP. In the presented case, the pacing lead was implanted at a depth of less than 12 mm, resulting in constant movement of the part between the ring and tip electrodes. Such mechanical stress may have provoked the observed conductor fracture (Figures 1 and 2). Also, the more basal implantation site close to the tricuspid valve, as in the presented case, might have resulted in a higher degree of motion stress on the lead.

According to published data, the mean LBBAP implantation depth, measured by echocardiography, was described as about 14 mm.⁸ It may thus be speculated that a deeper implantation depth, covering the ring electrode with myocardial tissue, might protect the interelectrode space and might help avoid mechanical stress-mediated lead fracture. Careful clinical observation is warranted to identify an excess rate of lead fractures at the culprit location in patients who underwent LBBAP. Whether this could be a specific problem of stylet-driven leads or might also apply to lumenless leads needs further surveillance. As a perspective, it might be advisable to ensure implantation at an oblique angle for sufficient implantation depth or select patients in whom at least some degree of septal hypertrophy is present to allow for the required implantation depth for stylet-driven LBBAP.

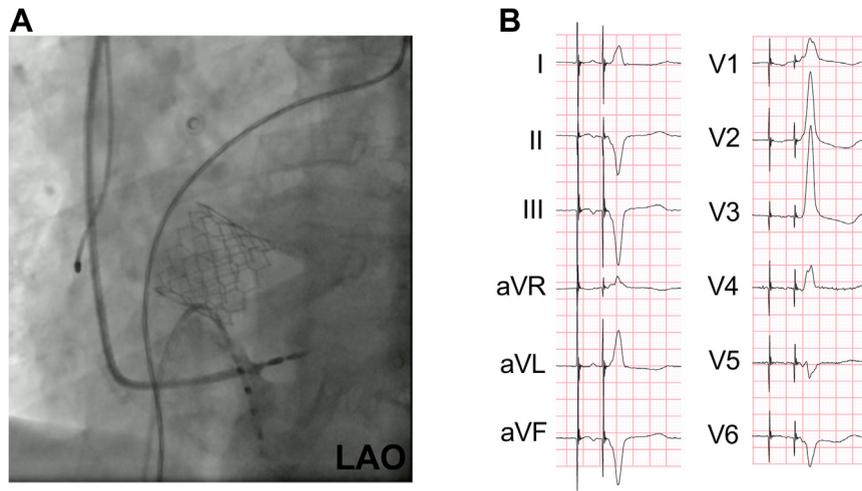
Figure 3 A: Left anterior oblique (LAO) projection demonstrating implantation depth during contrast dye injection at lead revision. B: Left bundle branch area pacing in 12-lead electrocardiogram after lead revision (50 mm/s).

using the inserted stylet, unscrewing, and slight traction. A new LBBAP lead (Biotronik Solia S60) was inserted as described above in a slightly more apical direction with a deeper penetration into the RV septum using a Biotronik Selectra 3D 40-42 sheath, resulting in physiological pacing (Figure 3A and 3B). A detailed investigation of the extracted lead by the manufacturer confirmed the conductor fracture at the described site, possibly provoked mechanically by the septal contractions with every heartbeat. No further damage or lead anomalies were revealed.
