Leadless pacemaker interrogation interference after conversion of a left ventricular assist device

(Heart Rhythm Case Reports 2022; ■:1–3)

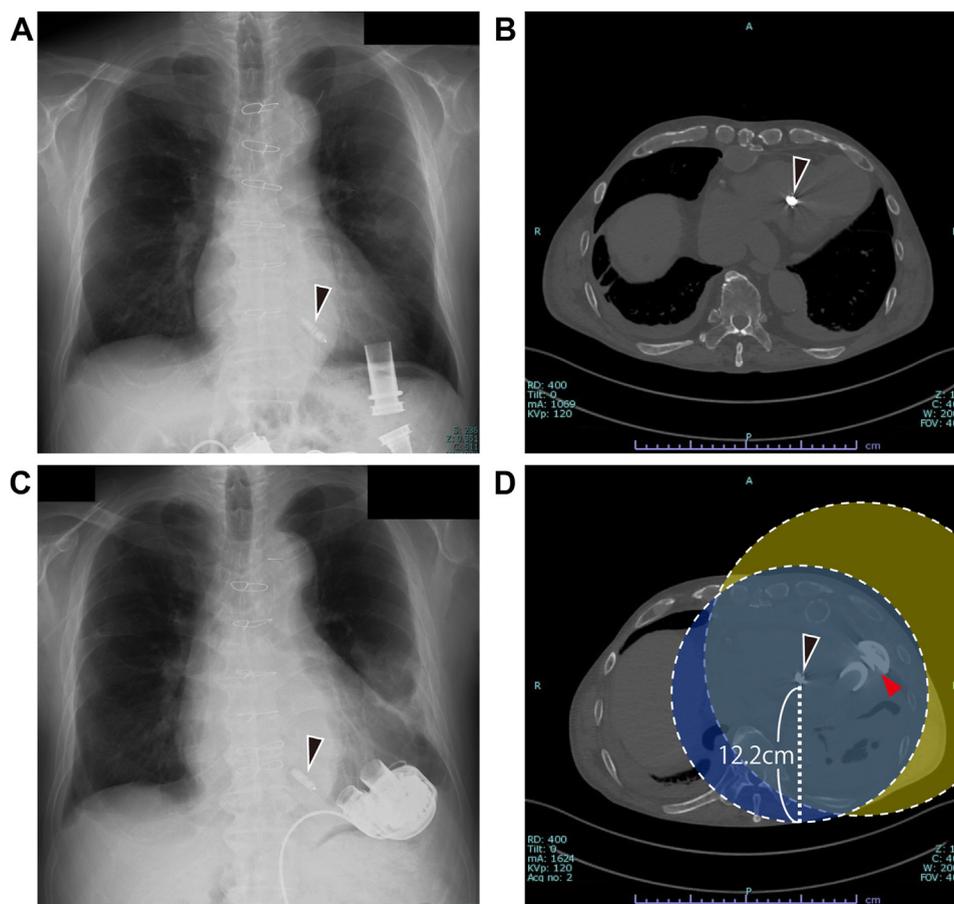
Figure 1 A: Chest radiograph with the leadless pacemaker and HeartMate (HM) II. B: Axial view of chest computed tomography. HM II is not in the same plane as the leadless pacemaker. C: Chest radiograph with the leadless pacemaker and HM 3. D: Axial view of chest computed tomography with the leadless pacemaker and HM 3. The blue circle indicates the presumed pacemaker programmable area, and the orange circle is the presumed LVAD EMI area. Black arrowhead: leadless pacemaker head; red arrowhead: HM 3.

In the current case, the pacemaker could initially be interrogated at the normal precordium position when HM II was implanted (Figure 1A and 1B). However, converting to HM 3 shortened the distance between the leadless pacemaker and the LVAD (Figure 1C and 1D), resulting in EMI between the programmer head and the pacemaker. We could not use a Faraday cage, as the device was in the heart, and the rotation

frequency could not be changed because the LVAD was HM 3, which operates between 3000 and 9000 rpm. Hence, we decided to increase the distance between the programmer head and the LVAD, while not changing the distance between the pacemaker and the programmer head. As the pacemaker was in the same horizontal plane as the HM 3 (Figure 1), we interrogated from the back of the patient, maintaining the same distance as from the pacemaker to the precordium, but increasing the distance from HM 3, which we did successfully. As shown in Figure 2, only a narrow range could be interrogated owing to subtle differences in location. We presumed that this location was right outside of the LVAD EMI distance and inside the pacemaker programmable distance (Figure 1D). According to the manufacturer's instructions,¹⁰ the distance for interrogation with Micra and the programmer head should be less than 12.5 cm, which was 12.2 cm to the back in the current case.

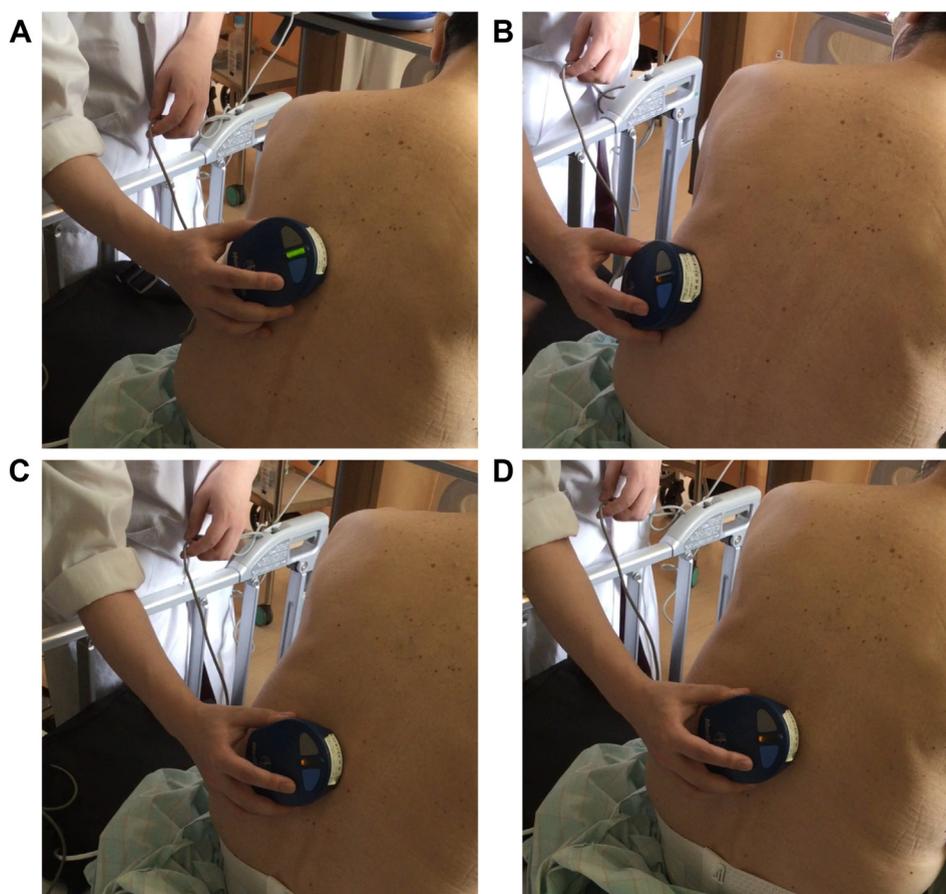
Figure 2 Photographs of the programmer head in slightly different locations. The color of the programmer head is green when interrogation is available (A) and orange when it is unavailable (B–D).
